Manhole Inspection Summary

Manhole # S37YY_017MH

Insp Date: **12/28/06 9:04 AM**

Location Address: **3106 BRENTWOOD AVE**

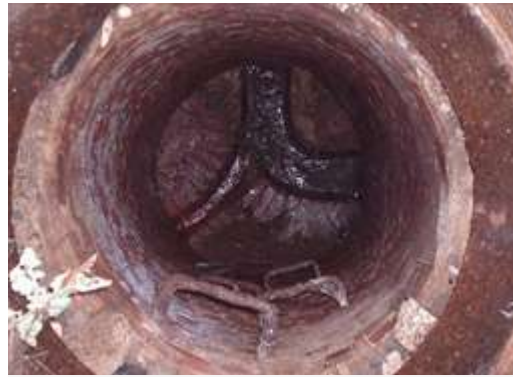
Top View

Corroded steps. Bench debris.

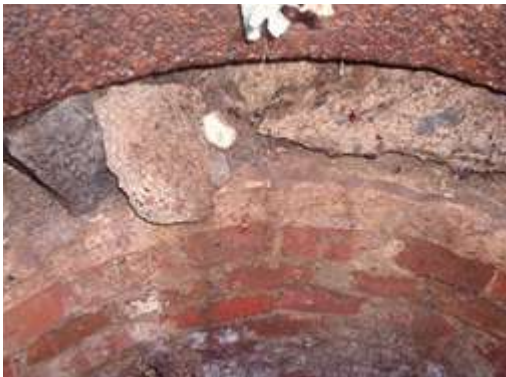
Defect

Frame leaks. Adjustment deterioration, loose brick and infiltration. Corbel infiltration.

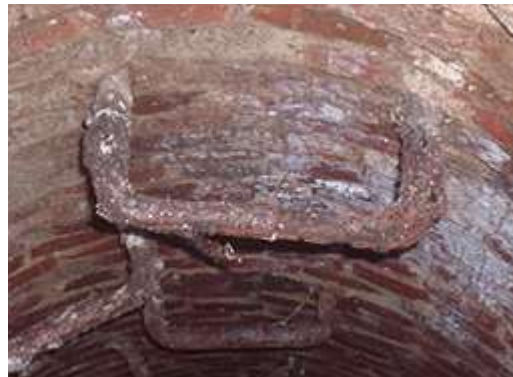
Defect

Corbel infiltration.

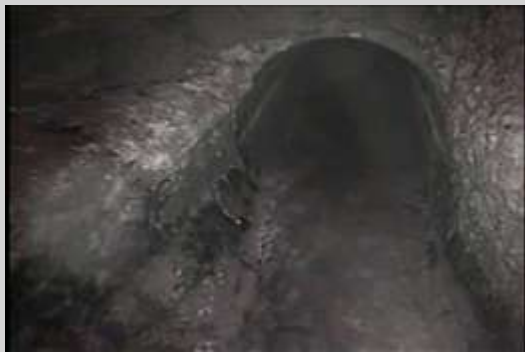
12 in. Circular Gravity Sewer Pipe Out @ 12 O'Clock

Deposits: ☐ None ☒ **Mud** ☐ Sludge ☐ Debris ☒ **Grease**

Infiltration: **Evidence** Pipe Seal Cond: **Unknown**

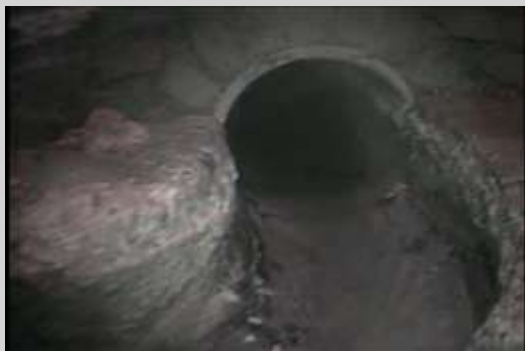
12 in. Circular Gravity Sewer Pipe In @ 3 O'Clock

Deposits: ☐ None ☐ Mud ☐ Sludge ☐ Debris ☒ **Grease**

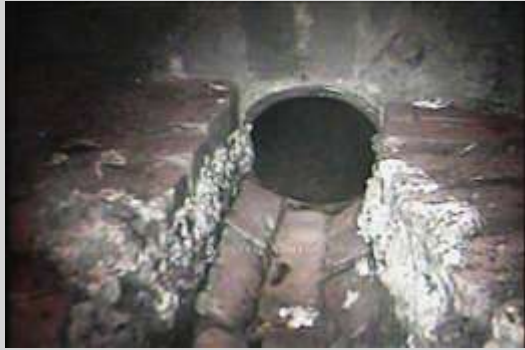
Pipe In @ 8 O'Clock

Channel deterioration.

Infiltration: **Evidence**
